## **SPECIAL NOTICE TO CUSTOMERS & DEALERS**

### **Possible Blockage of Nuvair O<sub>2</sub> Quickstick Sensor End Cap Sampling Orifice**

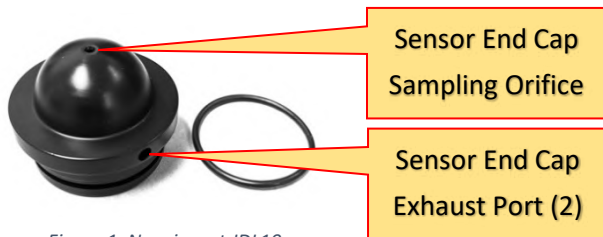
Figure 1. Nuvair part JDL10.  
O<sub>2</sub> Quickstick sensor end cap & O-ring.

During the production of Nuvair O<sub>2</sub> Quickstick sensor end caps, the sampling orifice at the tip of the cap may be blocked by a small piece of plastic. While this thin layer of plastic is easily removed, it can prevent the O<sub>2</sub> Quickstick from functioning properly and may impact diver safety.

This issue may affect Nuvair O<sub>2</sub> Quicksticks manufactured from 01/01/2024 to 03/18/2024 with serial numbers of AQ0385477-AQ0385677.

- (1) Place mouth over the hole of the sampling orifice and suck gently. If the orifice is clear, air will enter from the two (2) exhaust ports located on the sides of the sensor end cap (see Figure 1). If the orifice was blocked, a pinhead-size piece of black plastic may enter your mouth. Be careful not to inhale the plastic piece.
- (2) If the obstruction cannot be cleared, remove the sensor end cap from the oxygen sensor and visually inspect the sampling orifice (see Figure 2). If the orifice is blocked, use a straightened paperclip to clear the blockage from the orifice. Once the orifice is confirmed to be clear, replace sensor end cap.

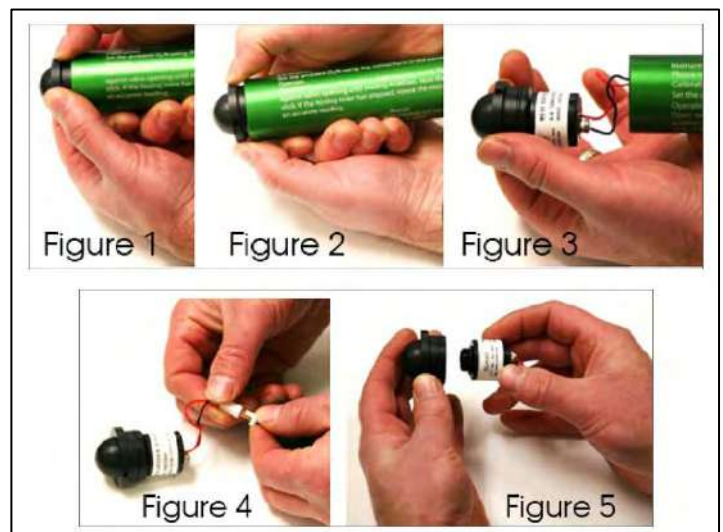
Figure 2. Removal and replacement steps.

For additional assistance with removal of the sensor end cap, watch our one-minute YouTube video, "O<sub>2</sub> Quickstick Sensor Replacement," at <https://youtu.be/4GILLmdNywk>.

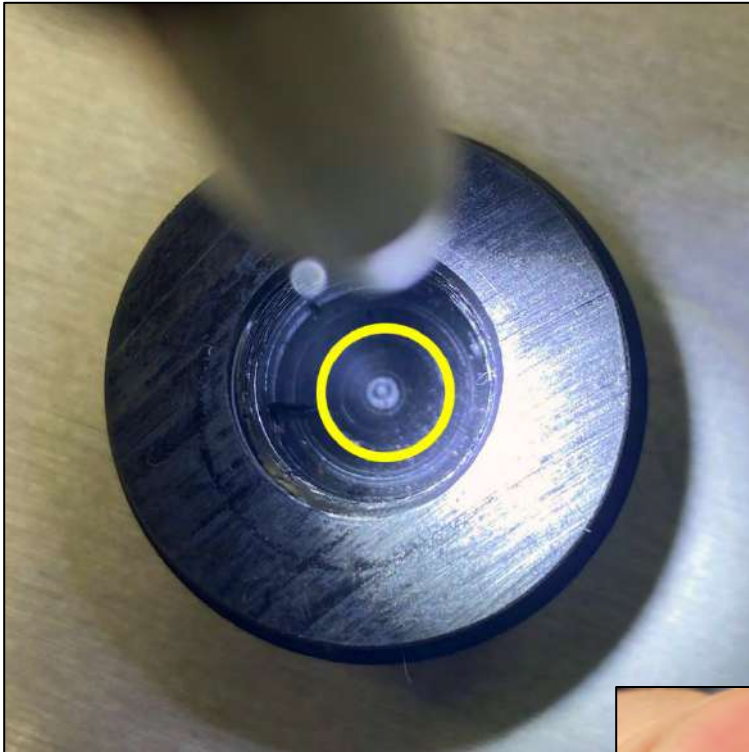
*Figure 3. Aided with a flashlight, obstruction as viewed from inside sensor end cap.*

These images show the sensor end cap orifice obstruction. The orifice is highlighted with a yellow circle. Both images are views of the sensor end cap where the oxygen analyzer is screwed into place.

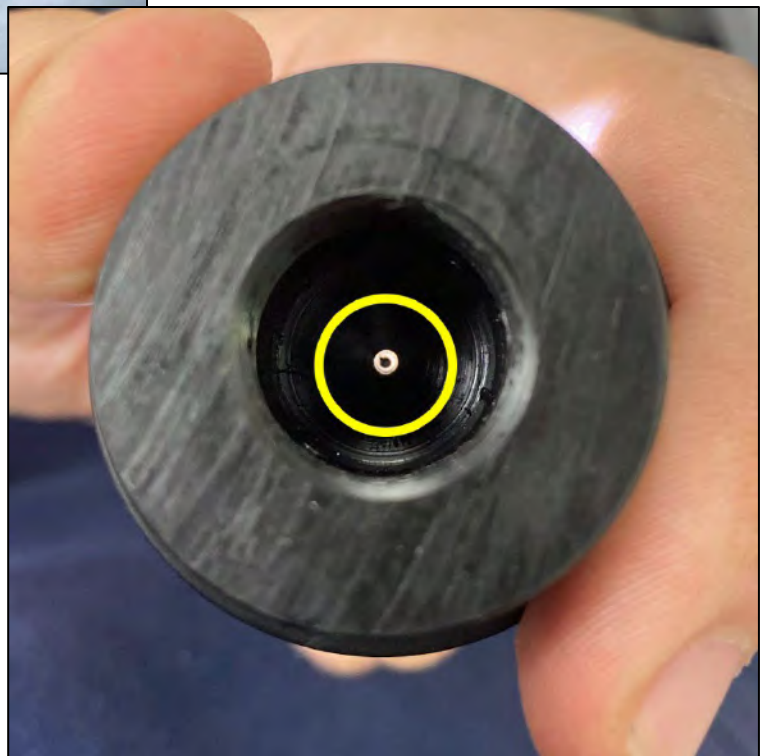
*Figure 4. With flashlight pointed at tip of sampling orifice, obstruction as viewed from inside sensor end cap.*

As shown in Figure 4, the plastic obstruction is paper-thin and can be easily cleared with a straightened paperclip or by blowing into the orifice when the sensor end cap is unscrewed from the oxygen analyzer.
